Remote sensing time series of an inundated saltmarsh

Andrew McGrath, Jorg Hacker, Wolfgang Lieff and
Ryan McAllister
Airborne Research Australia

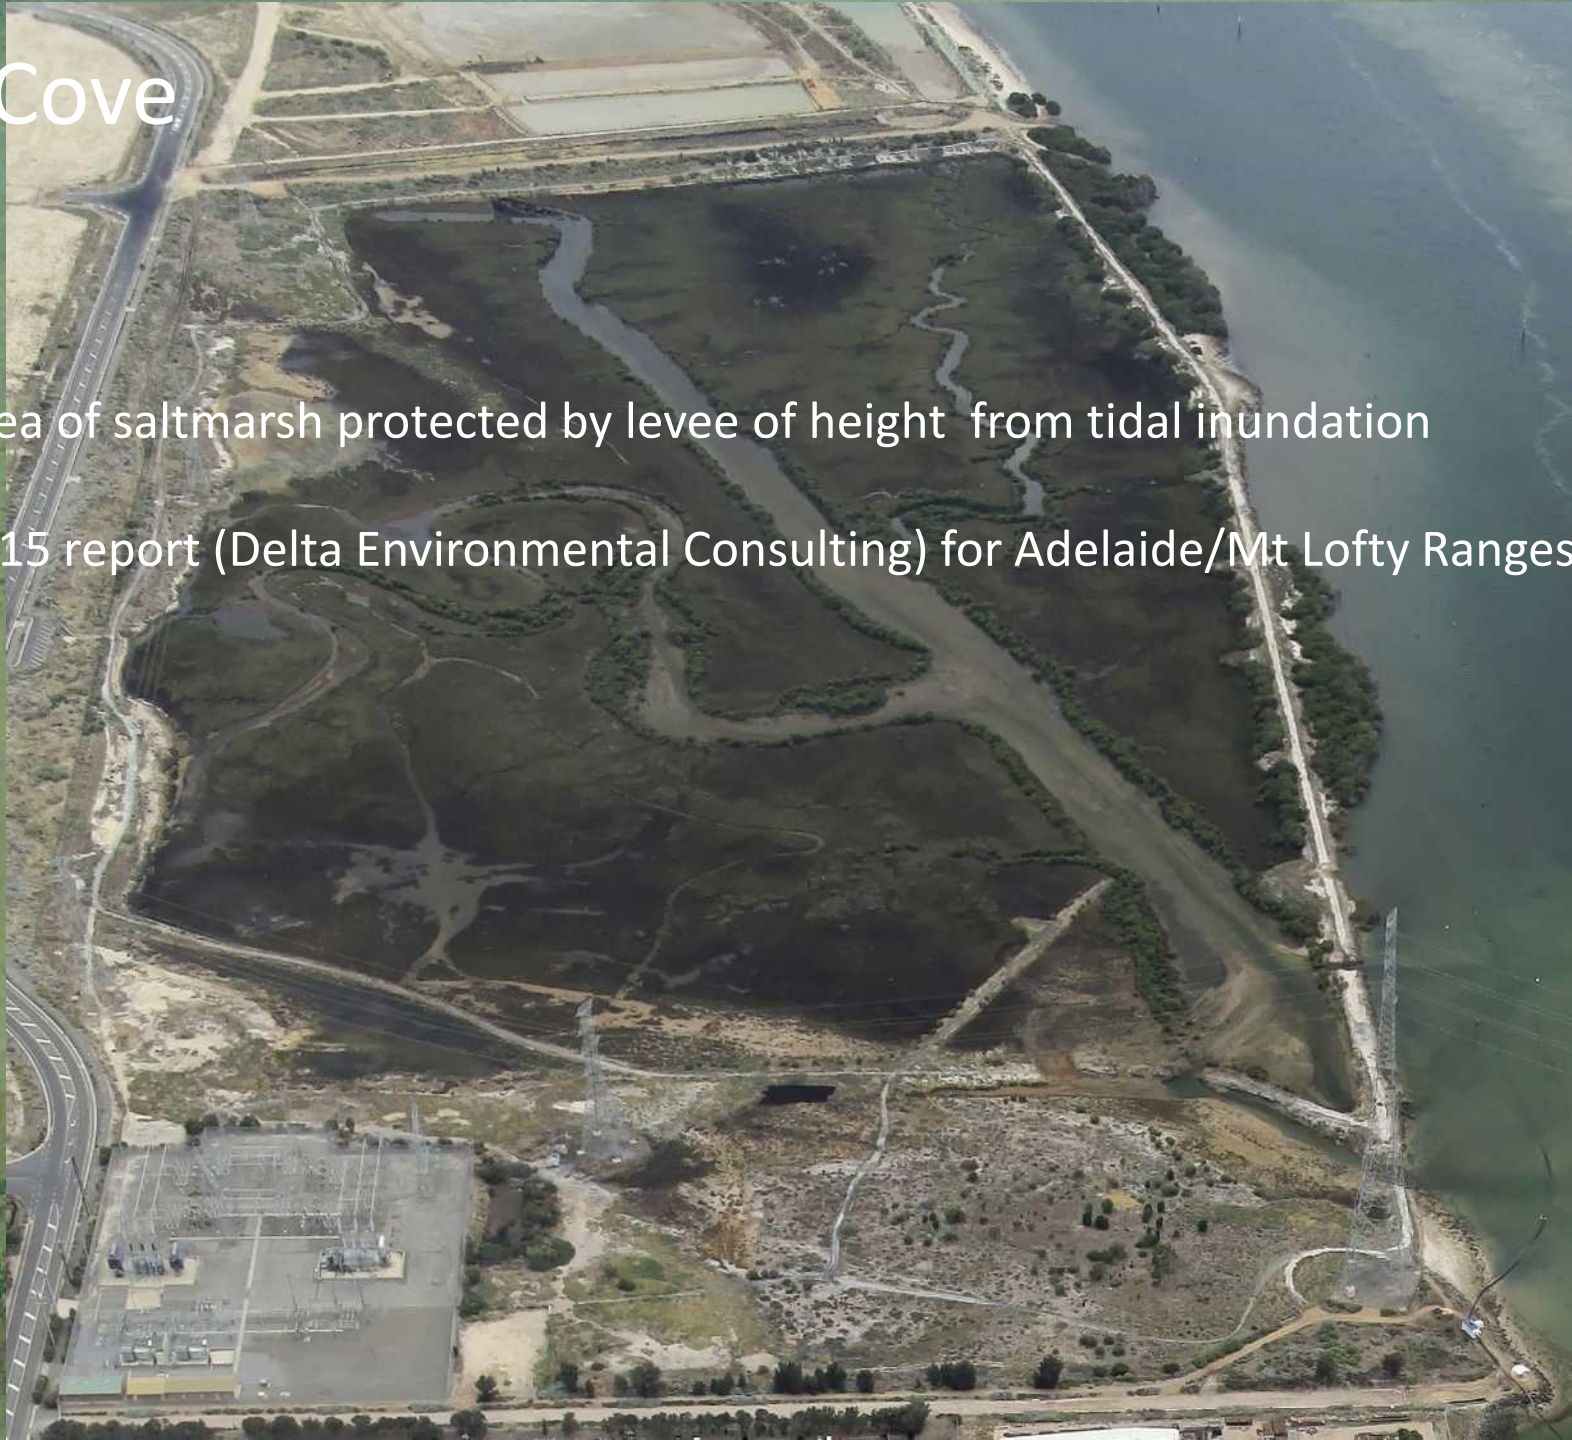
Mutton Cove

Area of saltmarsh protected by levee of height from tidal inundation

2015 report (Delta Environmental Consulting) for Adelaide/Mt Lofty Ranges

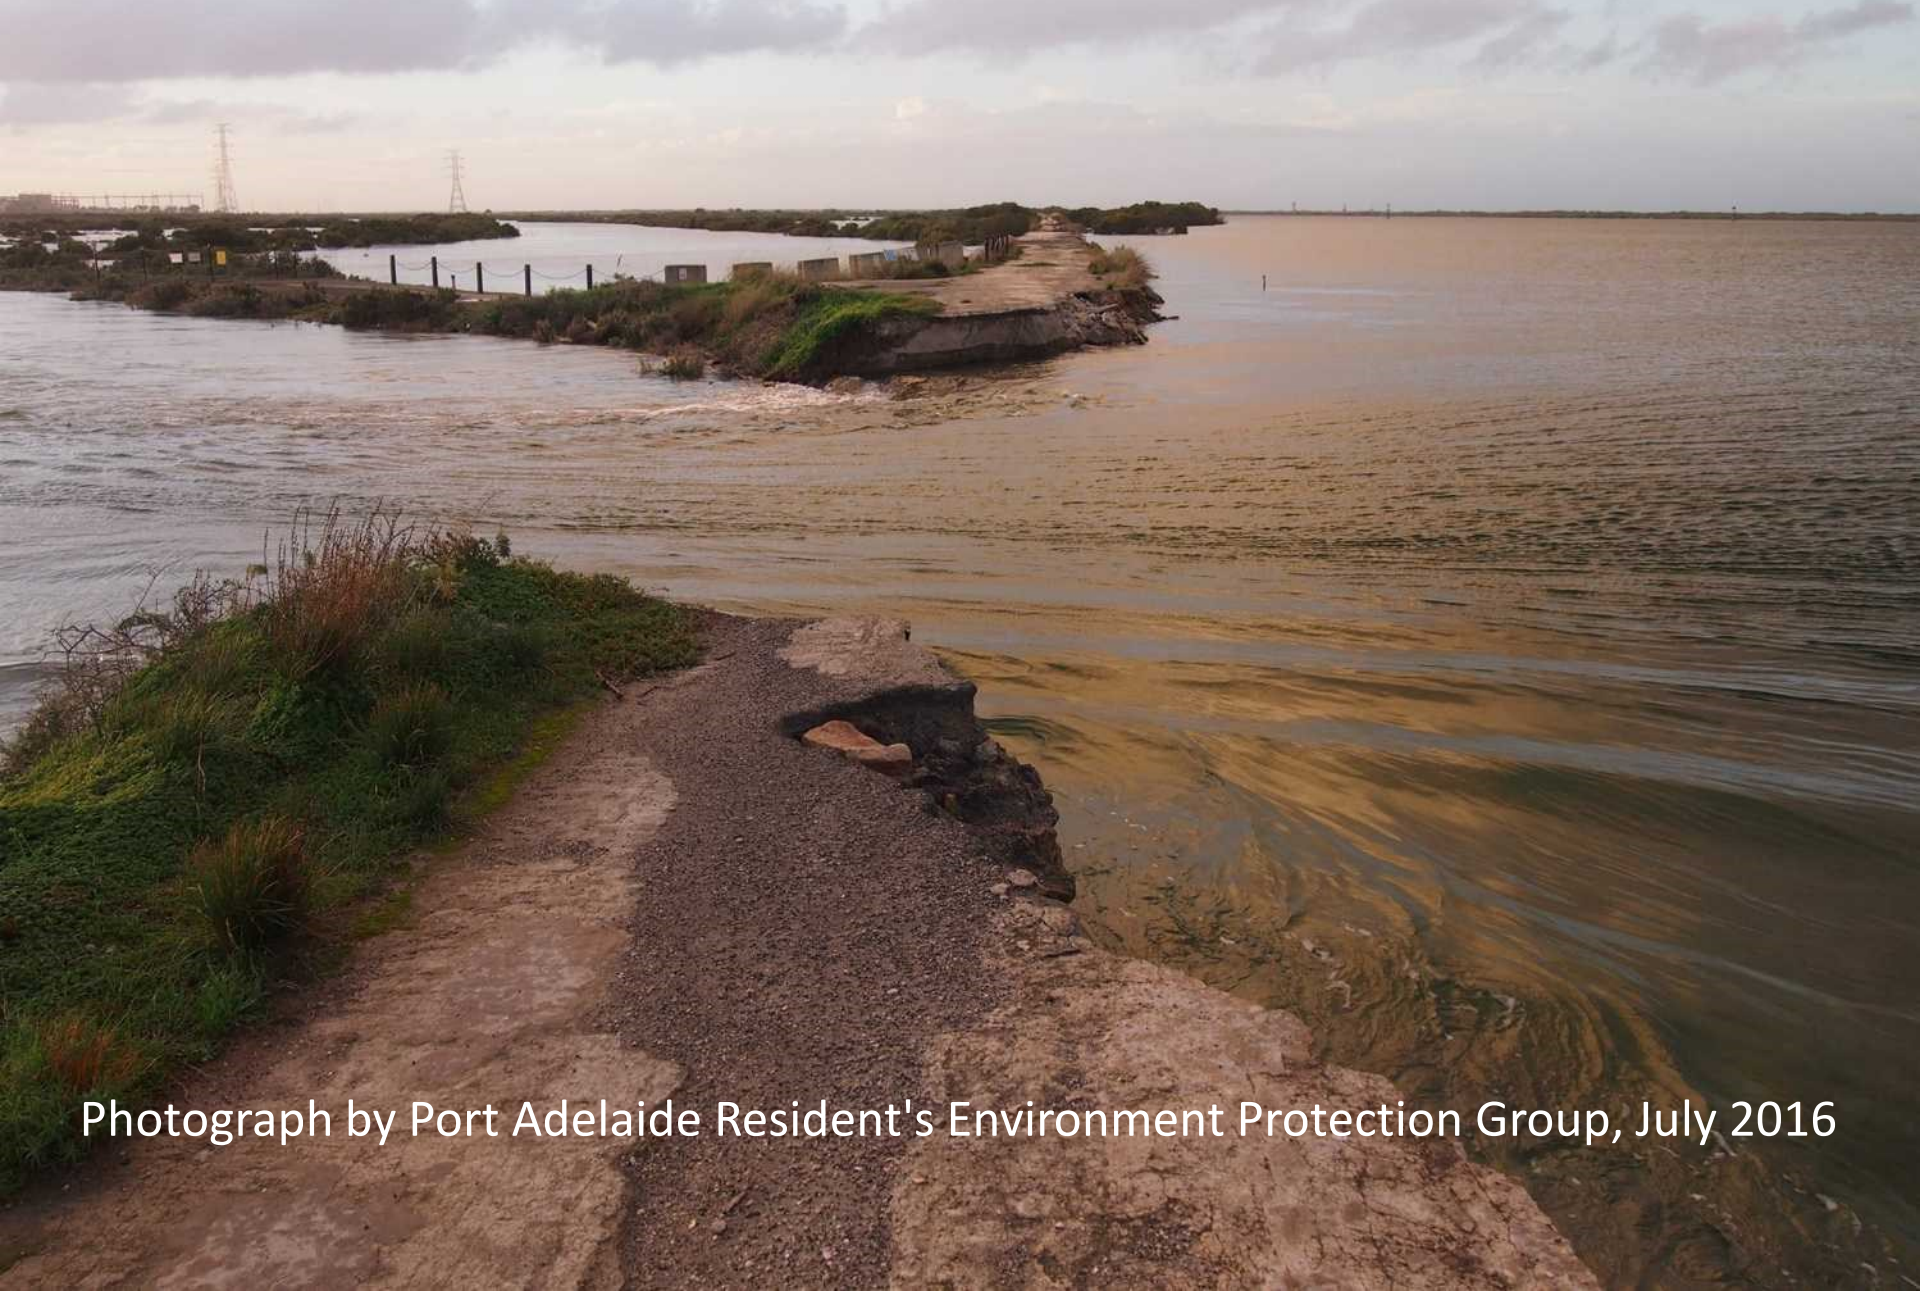
Photograph by Port Adelaide Resident's Environment Protection Group, July 2016

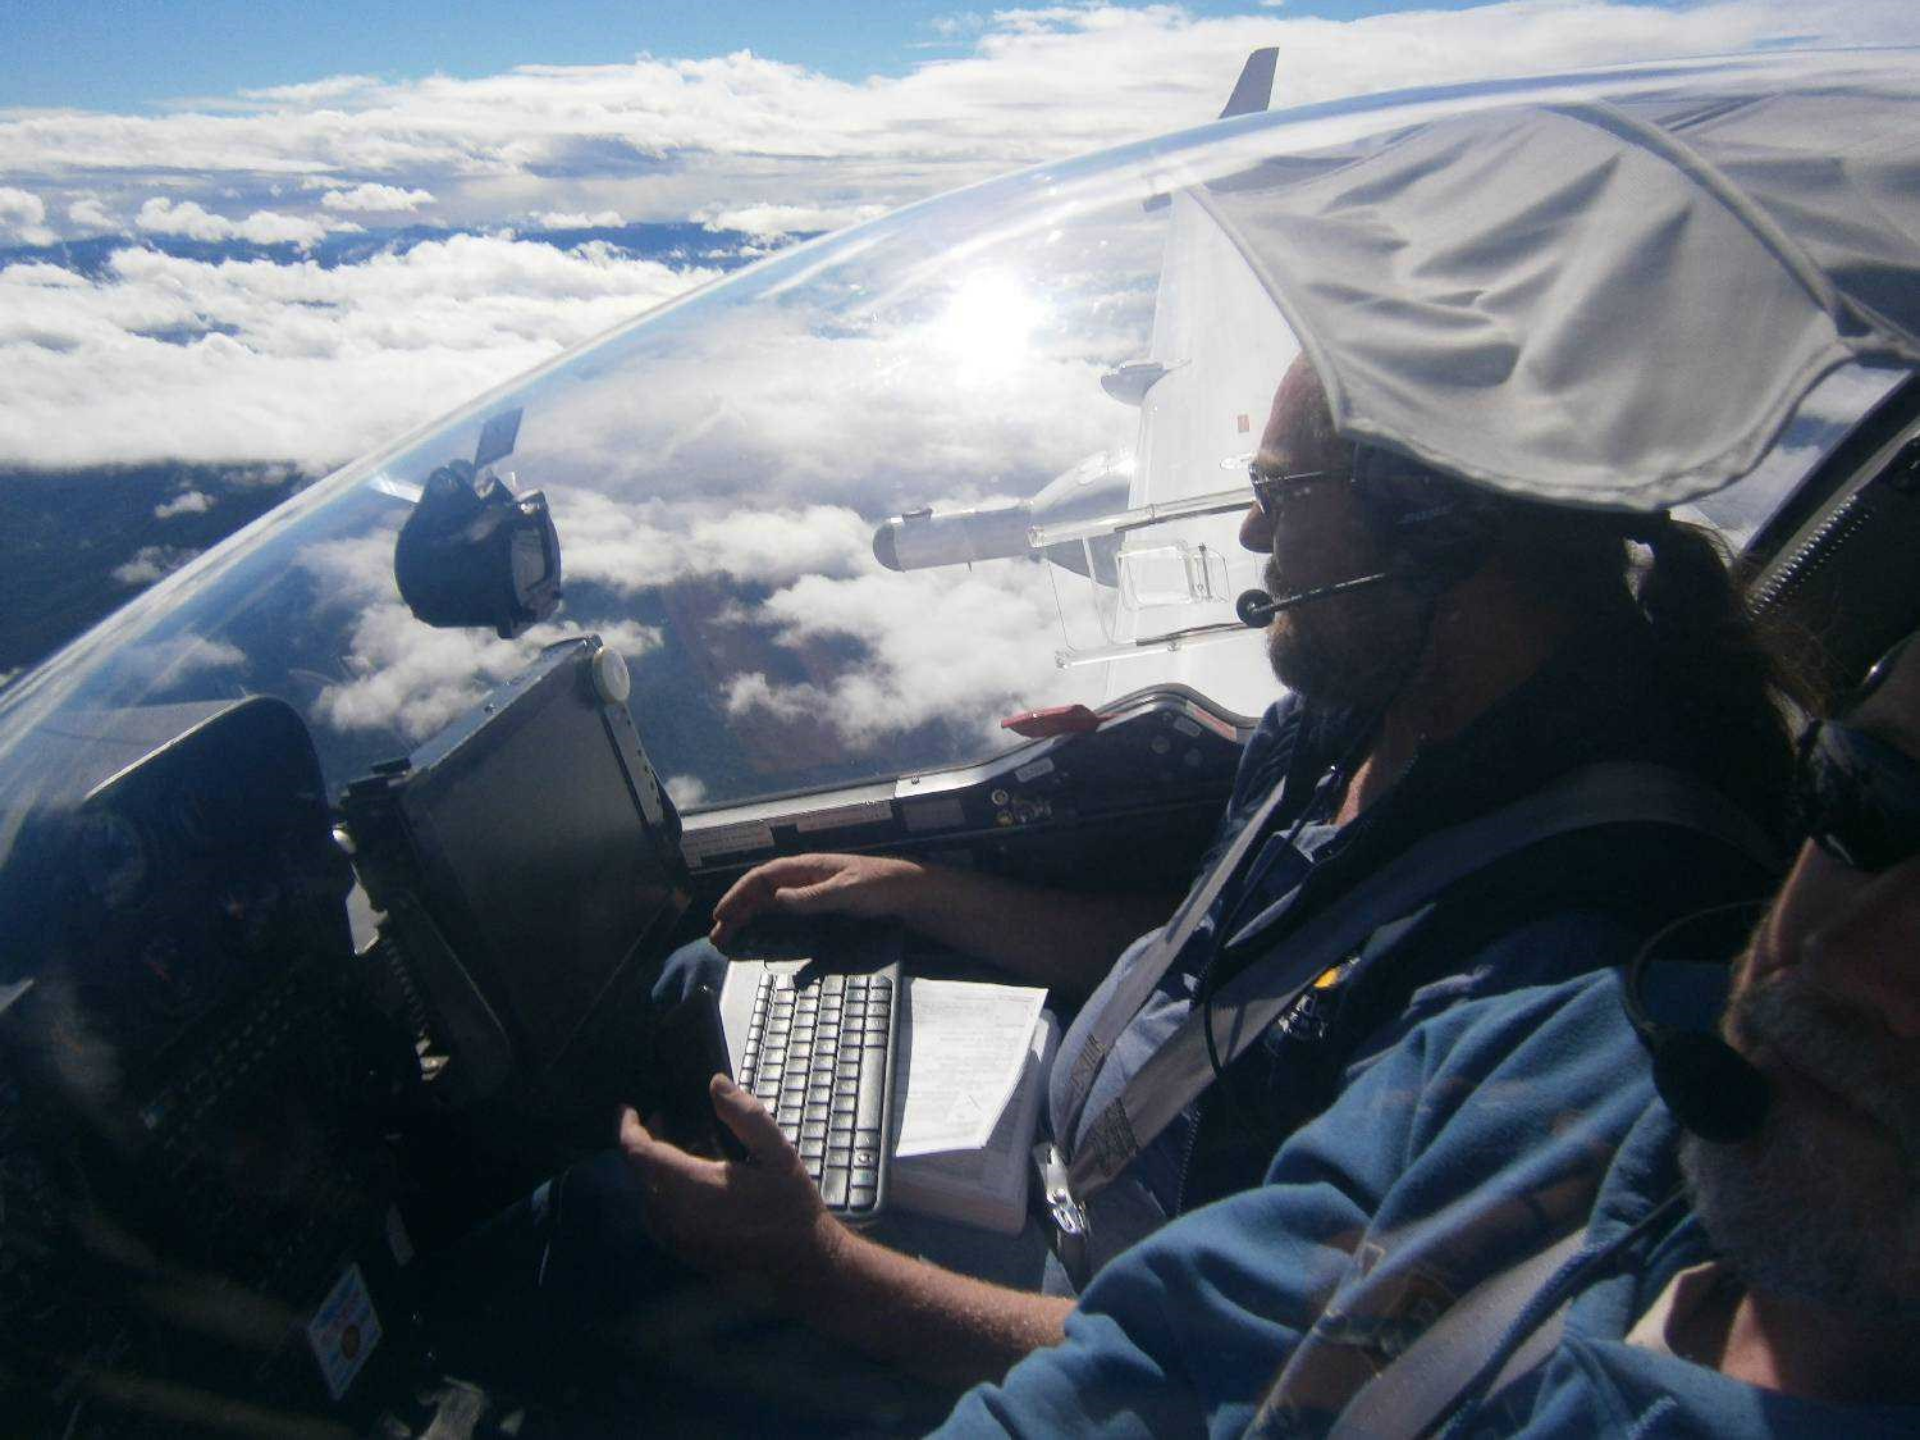
HK-36 Eco-Dimonas, EOS & OBS

- Normally operate with two crew – pilot + scientist

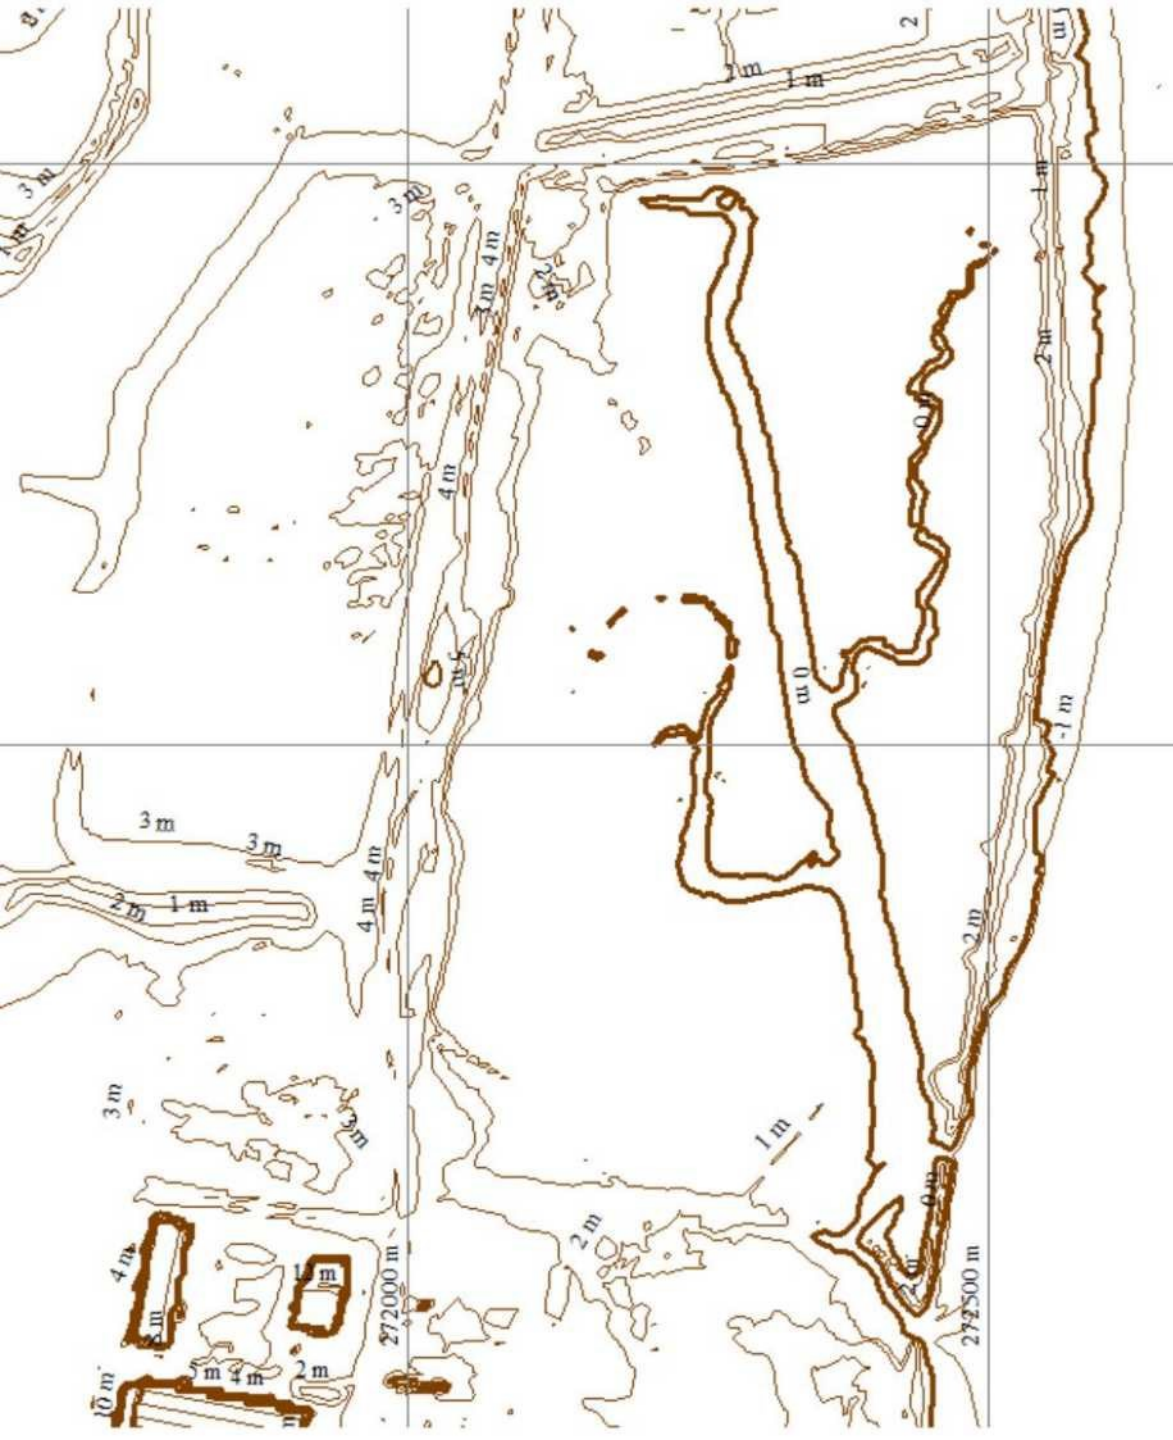
Contour map
of terrain model
available through
time

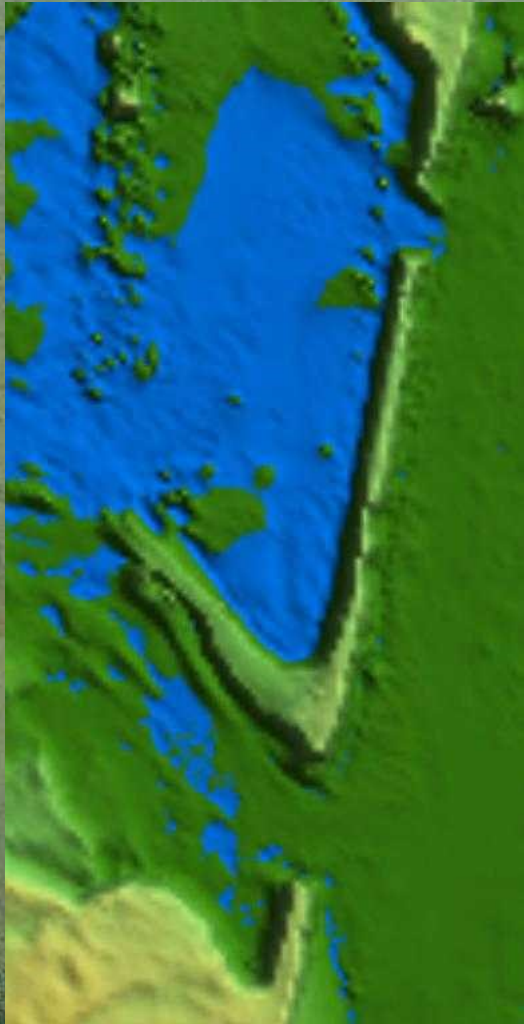
Dec 2016

Lidar records erosion of breach

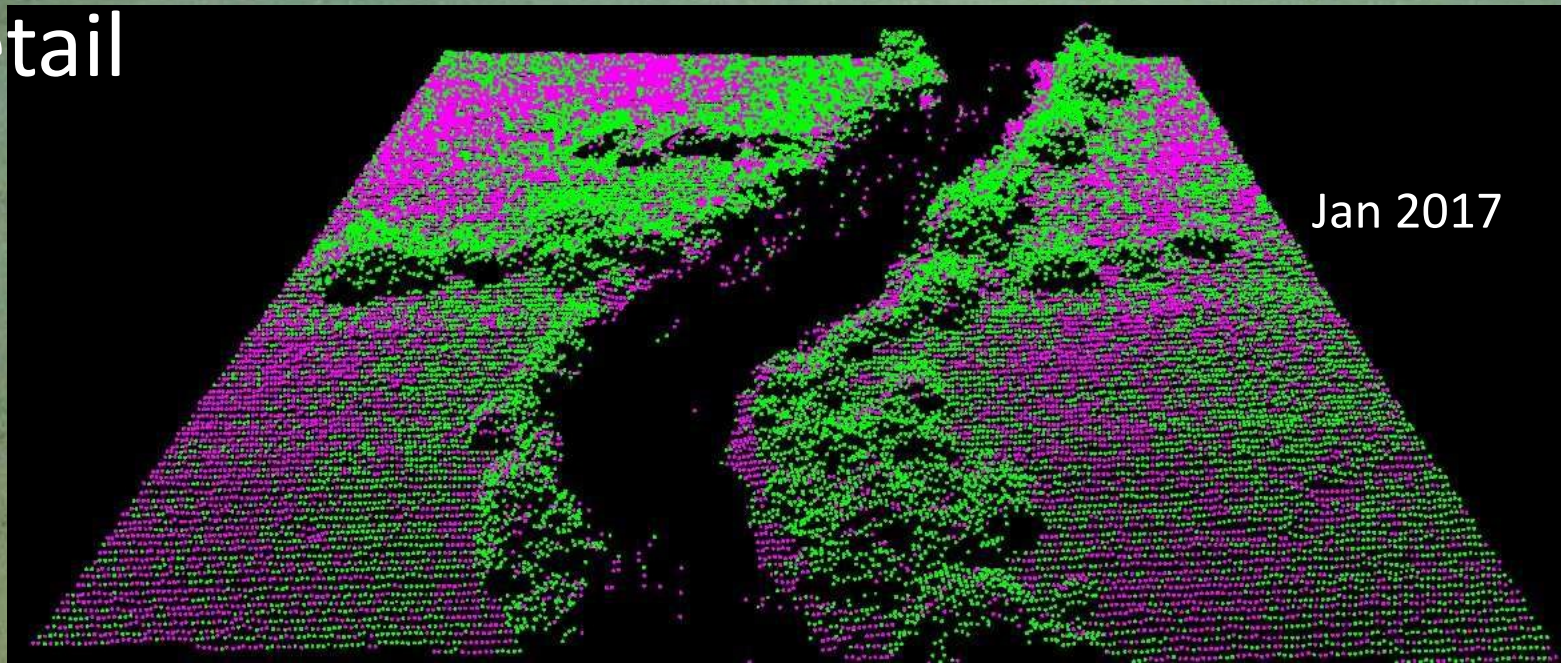
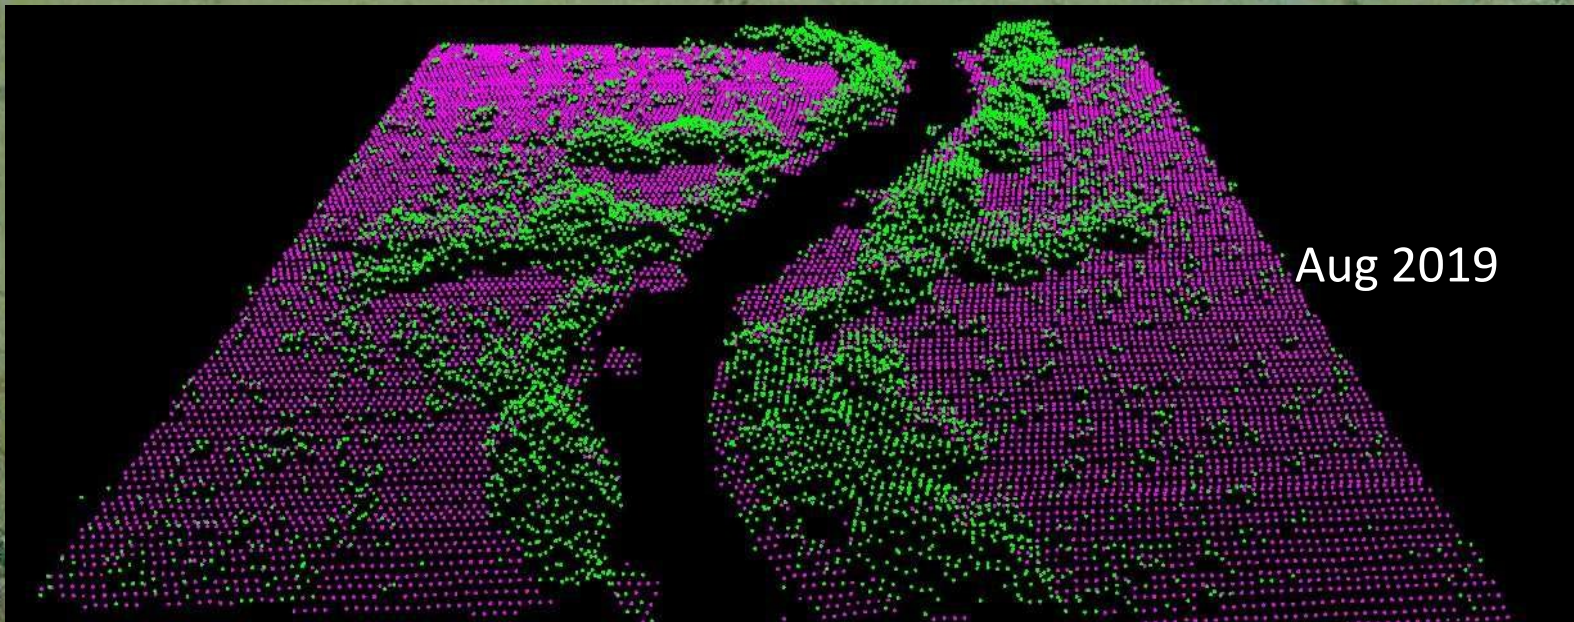
Lidar detail

Lidar shows reduction in samphire and growth of mangroves
